INSPECTION REPORT

PRE-PURCHASE

SUBJECT: PRE-PURCHASE INSPECTION OF CORNEILLE STREET, BROSSARD (QC)
J4Z 0K2.

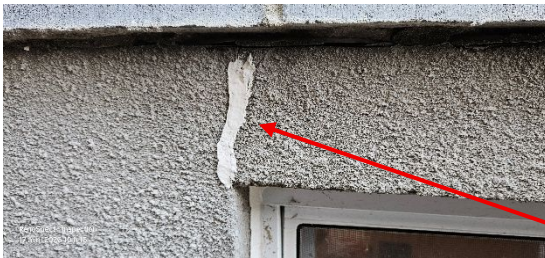
A careful examination of the poured concrete foundations reveals several cracks measuring less than 3 mm (1/8 inch). This condition may be stable or indicative of structural problems (e.g., loss of soil bearing capacity beneath the footings). It allows water to infiltrate the building and cause frost heave. Without **corrective measures to seal** these cracks, this situation can worsen and affect the building in the future.

Foundations
Observed crack (-3mm / 1/8 inch)
Window (top) - Left side

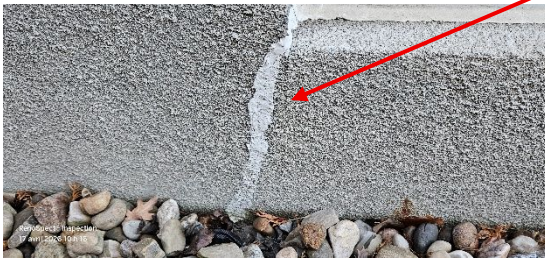
Foundations
Observed crack (-3mm / 1/8 inch)
Window (bottom) - Left side

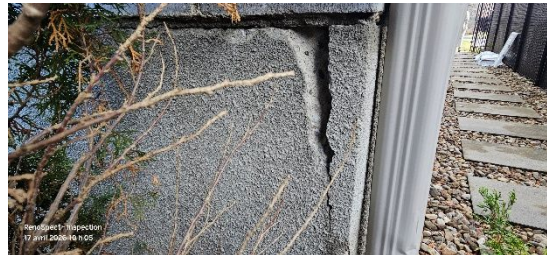
A careful examination of the foundation reveals a crack measuring over 3 mm (1/8 inch) on the rear left side of the building's foundation. This condition allows water to seep into the building and cause frost heave. It indicates a problem with the flashing of the exterior cladding above the foundation and **requires immediate repair** .

Foundations
Crack Observed (+3mm / 1/8 inch)
Back left corner

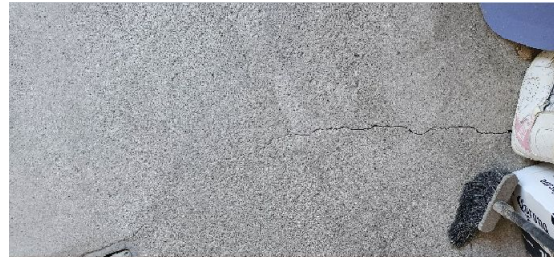
A careful examination of the concrete slabs reveals cracks in the garage slab. Cracks resulting from normal shrinkage are acceptable unless their width exceeds 1/8 in. (3 mm). This condition does not represent a pyrite-related phenomenon, which is primarily observed as slab heave in the basement and/or garage due to backfill swelling. Since 1999, the construction industry has voluntarily applied the CTQ-M100 standard. As this is not a mandatory standard, homeowners should require contractors performing construction or renovation work under the concrete slab to provide the original delivery slip confirming that the crushed stone used is certified "DB". Remedies **for repairing** these cracks may include epoxy injection, flexible injection, or the application of a suitable membrane.

Concrete slab
Cracks observed
Garage

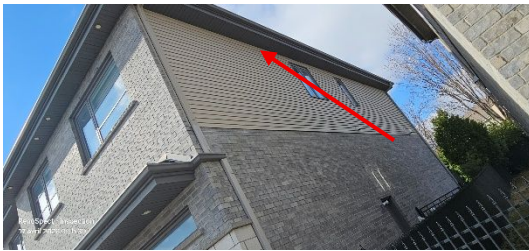
A careful examination of the exterior cladding revealed signs of improper installation of the aluminum siding. It is poorly secured to the starter strip. This condition **requires corrective action** to prevent problems such as:

- Movement or deformation of the panels (wind effect)
- Noises (clicking sounds)
- Risk of partial detachment
- Water or air infiltration behind the coating
- Premature wear of the fastening system

Aluminum clinker
Deformation
Right side

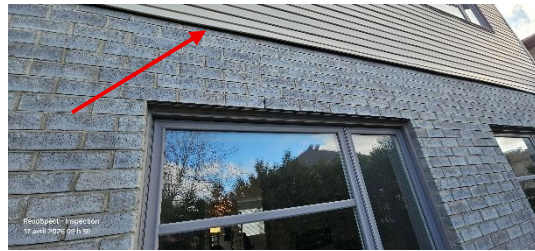
Aluminum clinker
Starting strip
Rear facade

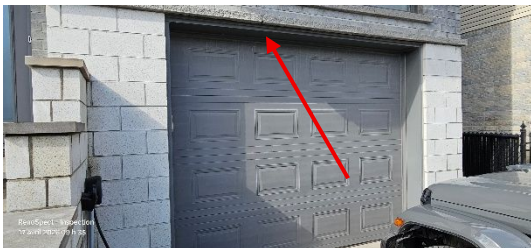
A careful examination of the lintels and sills reveals cracks or other damage to the masonry lintel above the garage door, indicating a degree of structural failure in this component. Masonry lintels and/or sills are installed to support the exterior wall cladding around door and window openings. This condition **requires corrective action** to prevent further damage.

Masonry lintel
Damage observed (1)
Garage door

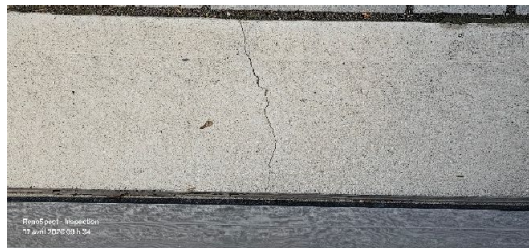
Masonry lintel
Damage observed (2)
Garage door

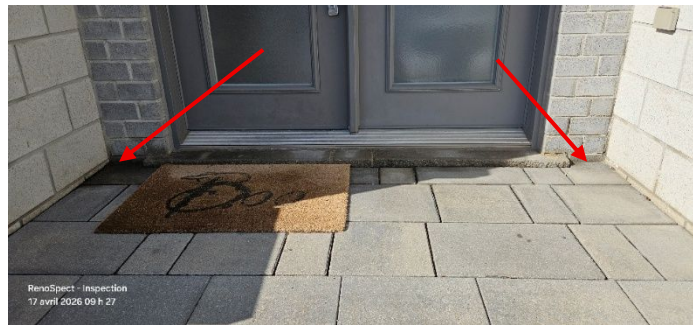
A careful examination of the terraces, balconies, and porches reveals that the front entrance balcony lacks the slopes necessary to drain water away from adjacent walls (where applicable). This condition allows water and moisture to seep below the surface, potentially leading to delamination, oxidation, cracking, or premature rotting of the components. Repairs **are required** to restore proper water drainage.

Entrance balcony - Water accumulation/infiltration
Front facade

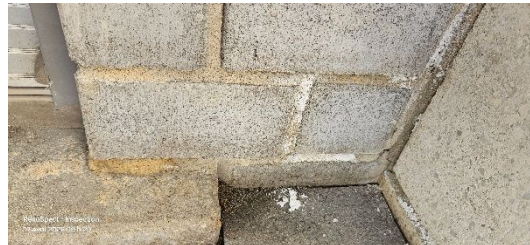
Entrance balcony - Efflorescence observed
Front facade

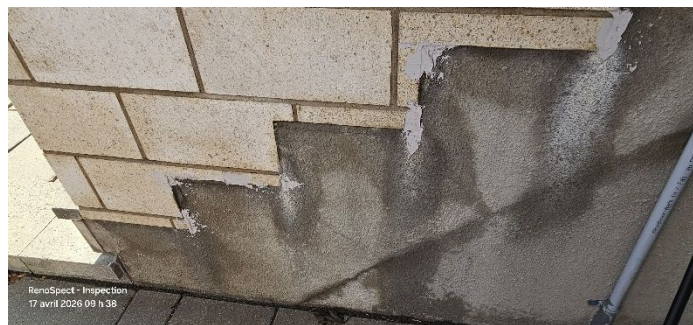
Entrance balcony - Infiltration
Front staircase

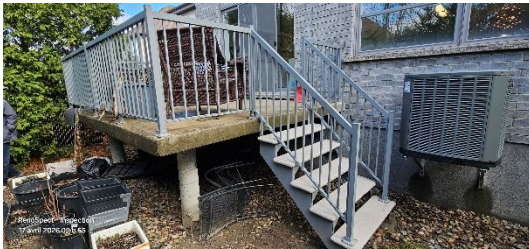
A careful examination of the exterior stairs reveals that the installation of the balcony staircase at the rear of the building does not comply with current building code standards. Regarding loads and/or lateral thrust, the staircase must be securely anchored to ensure safety. **Immediate corrective action is required** to prevent injuries.

Exterior stairs (1)
Inadequate anchoring
Rear balcony

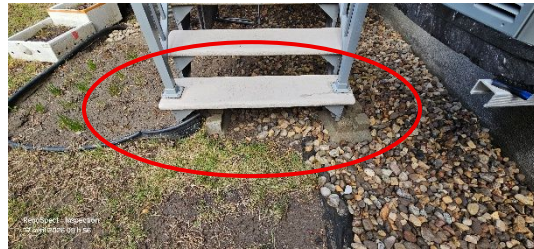
Exterior stairs (2)
Inadequate anchoring
Rear balcony

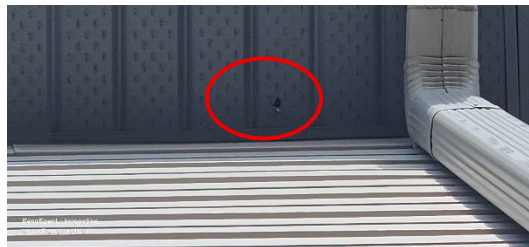
Soffits
Observed Damage
Left side

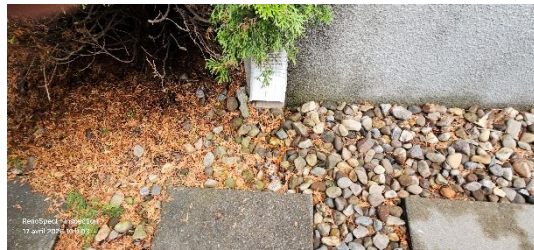
A careful examination of the gutters and downspouts reveals that some downspouts discharge water close to the foundation. This condition promotes water accumulation around the building and increases the risk of foundation leaks. Corrections **are required** to ensure that downspouts direct water a minimum distance of 2 m (6.5 ft) from the building. During site preparation, it is important to ensure a positive slope away from the foundation. If necessary, install deflectors to optimize drainage.

Rainwater downpipes
Drainage near the foundations
Left side

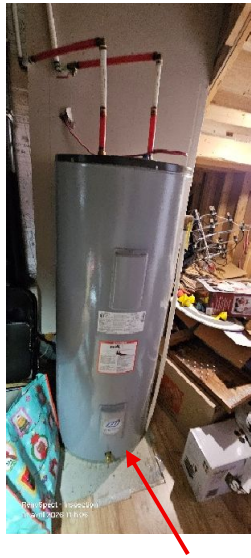
A careful examination of the water heater system reveals the absence of a sump beneath the water heater. It must be properly connected to a floor drain. Even if the water heater is functioning normally, this condition increases the risk of damage from leaks, especially if the water heater is over 10 years old. Corrective measures **are required** to rectify the situation.

Water heating system
Inadequate connection to the floor drain
(Mechanical chamber)

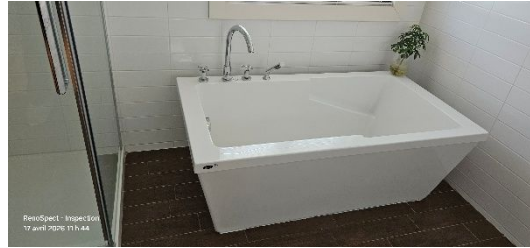
A careful inspection of the fixtures and faucets reveals that sealant joints are missing or damaged (bathtub, shower, sink, toilet, kitchen sink). Prevent water infiltration into adjacent walls, floors, or countertops. Without proper sealing, serious damage can occur to the components (mold, rot, etc.). Repairs **are required** to rectify the situation.

Appliances and taps
Sealant missing or damaged
Bathtub

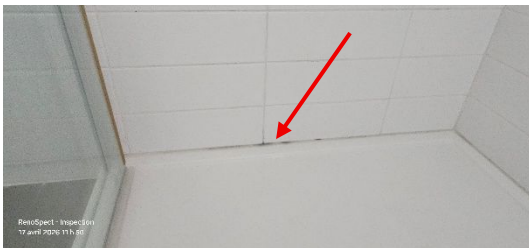
Appliances and taps
Sealant missing or damaged
Shower

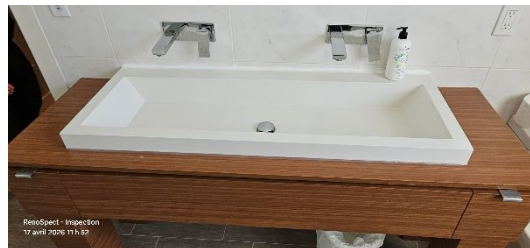
Appliances and taps
Sealant missing or damaged
Sink

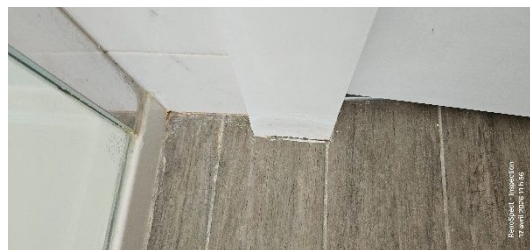
Appliances and taps – Infiltration (2)
Shower

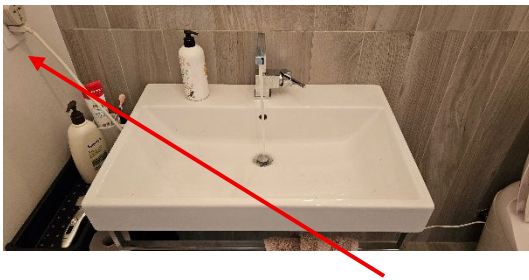
A careful examination of the light fixtures, outlets, and switches reveals a malfunction in a ground fault circuit interrupter (GFCI) outlet. Normal operation of this type of outlet should result in the circuit being disconnected when the test button is pressed and the circuit being reconnected when the reset button is pressed. The ground fault circuit interrupter (GFCI) is a highly sensitive protective device installed to guard against electric shock, especially in damp locations (outdoors, kitchen counters, bathrooms, etc.). This condition poses a high risk of electrocution and **requires immediate corrective action** to rectify the situation.

GFCI outlet malfunction
Bathroom

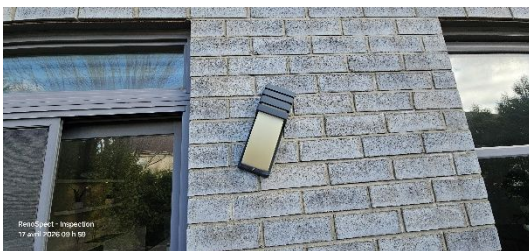
Light fixture - Inadequate mounting
Rear facade

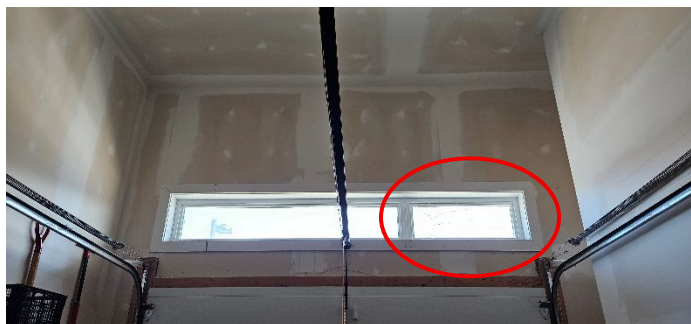
A careful examination of the interior doors and windows reveals a broken double-glazed unit in a window above the garage door. While breakage of double-glazed units from the inside, often perceived as "spontaneous," is primarily caused by internal physical stresses that exceed the glass's strength. Although there is no single cause, the critical threshold is often reached during extreme temperature differentials (e.g., 20°C inside / -30°C outside) . This condition **requires prompt corrective action** to restore the building envelope's energy efficiency.

Interior windows
Broken thermos glass
Garage

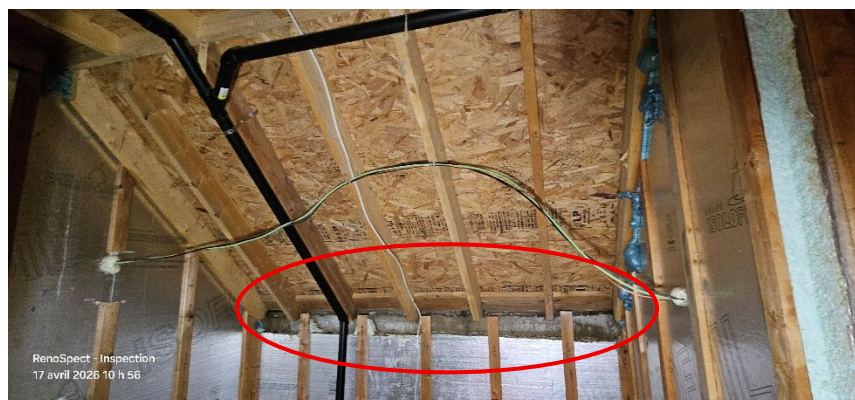
A close examination of the cold storage room reveals a noticeably high humidity level, which may be due to rising groundwater and surface runoff seeping through cracks in the top slab or via the exterior staircase. This condition can affect the foundation's ability to support the structure's weight. It can cause structural damage due to soil movement, damage organic materials (gypsum, wood, clothing, etc.), and promote the growth of microbes such as mold. Corrective measures **are required** to rectify the situation.

Cold room – Signs of leakage
Basement (front)

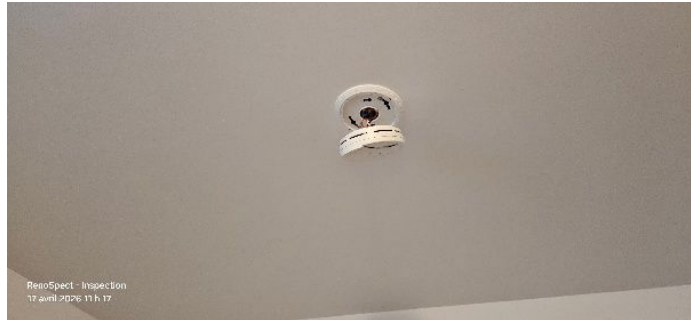
A careful examination of the fire alarms reveals the absence of several smoke detectors. This condition poses a risk to the safety of the occupants. **Corrective measures are required immediately** to rectify the situation.

Fire alarms
Absent or non-compliant
