INSPECTION REPORT

PRE-PURCHASE

SUBJECT: PRE-PURCHASE INSPECTION OF CORNEILLE STREET, BROSSARD (QC)
J4Z 0K2.

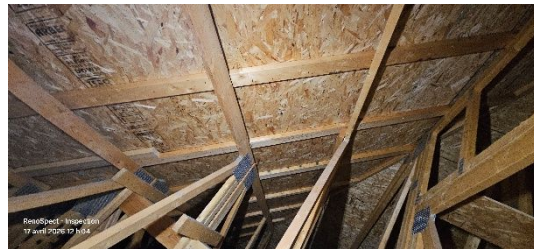
A careful examination of the prefabricated timber trusses and particleboard decking revealed no significant anomalies. Therefore, the inspector can confirm the absence of any apparent defects, indications of deficiency, or risks to the safety or physical integrity of this component at the time of inspection.

Decking
No major anomalies
Attic

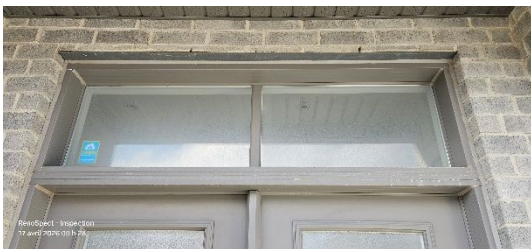
Sealant
No major anomalies
Front facade

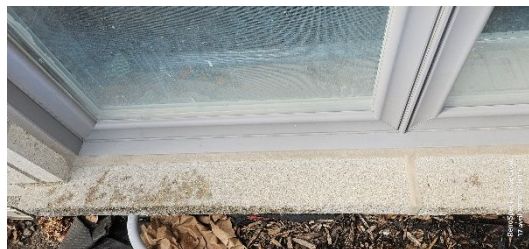
Sealant
No major anomalies
Front facade

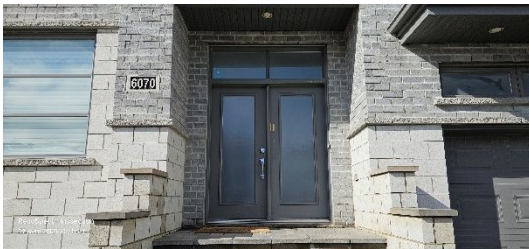
Front door
No major anomalies
Front facade

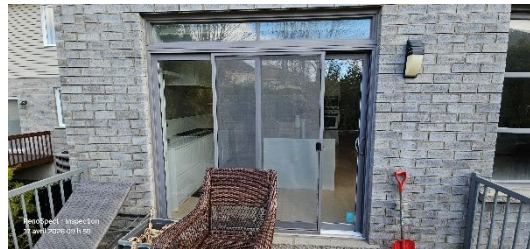
Patio door
No major anomalies
Rear facade

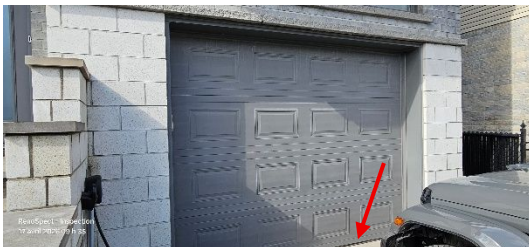
Garage Door – Maintenance (Air Vents)
No major anomalies
Front facade

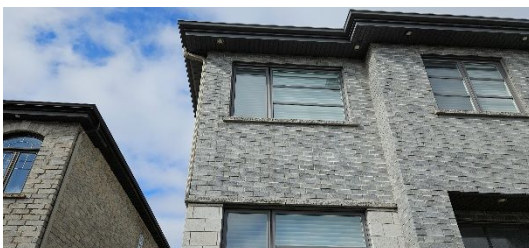
Exterior windows
No major anomalies
Front facade

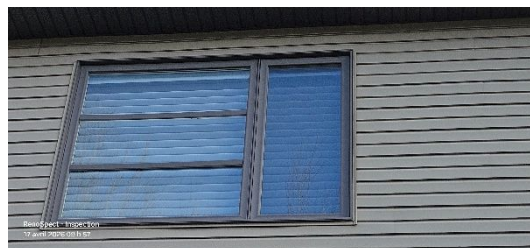
Exterior windows
No major anomalies
Front facade

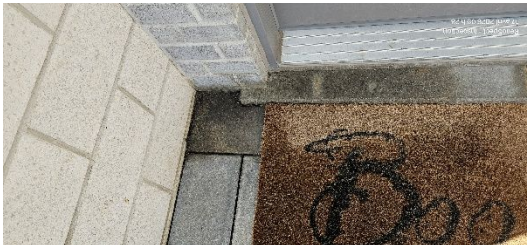
A careful examination of the terraces, balconies, and porches reveals that the front entrance balcony lacks the slopes necessary to drain water away from adjacent walls (where applicable). This condition allows water and moisture to seep below the surface, potentially leading to delamination, oxidation, cracking, or premature rotting of the components. Repairs **are required** to restore proper water drainage.

Entrance balcony - Damp patch
Front facade

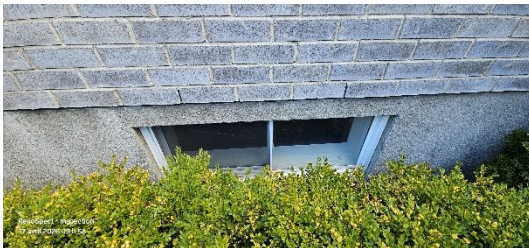
branches near the building should be regularly pruned to prevent damage to the roof and building envelope. Tree roots too close to the foundation can block the French drain, affecting its performance and shortening its lifespan. Furthermore, by absorbing moisture from the soil, the roots exert pressure on the foundation, potentially leading to cracks. Additionally, since backfill often settles around the perimeter of the foundation, the ground surface must be leveled to prevent water from accumulating along or near the building after the soil has settled.

Earthworks and landscaping
Presence of trees
Rear facade

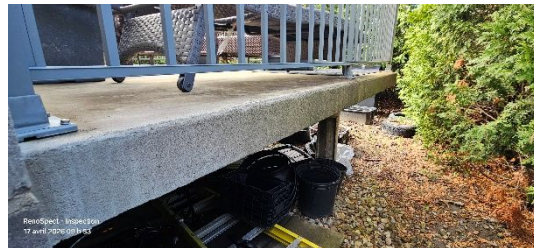
Earthworks and landscaping
Incomplete installation
Backyard

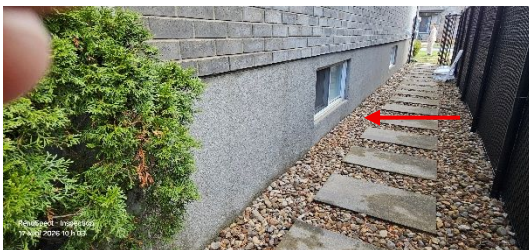
Earthworks and landscaping
Negative slopes
Left side

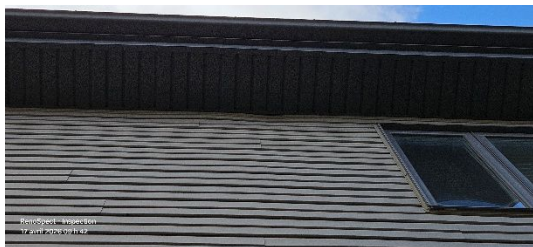
Soffits
No major anomalies
Rear facade

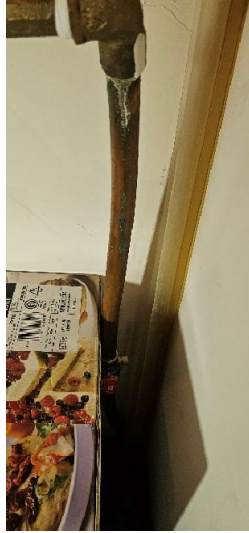
Water inlet (conduit)
No major anomalies
Basement

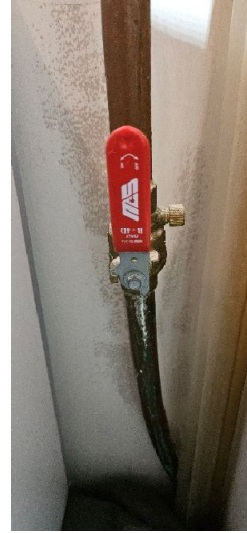
Water inlet (valve)
No major anomalies
Basement

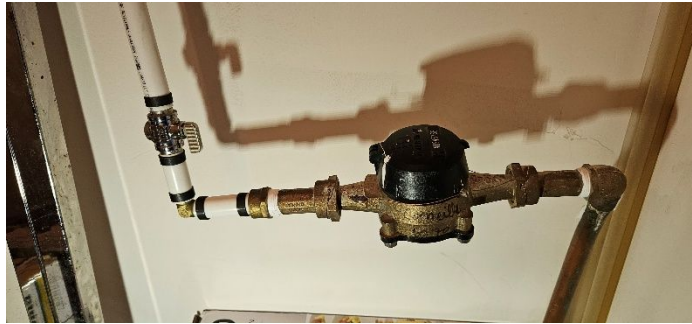
Water meters are devices that continuously measure and record the volume of water used in a building. They are equipped with a real-time remote reading system. Check with your municipality to see if a water tax applies to your building.

Main entrance
Water meter
Basement

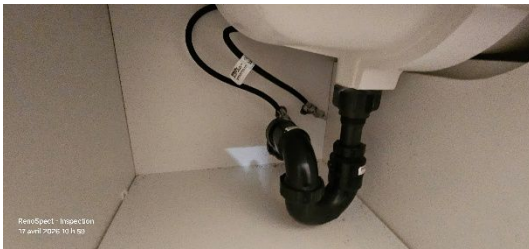
Drainage pipes (ABS)
No major anomalies
Sink

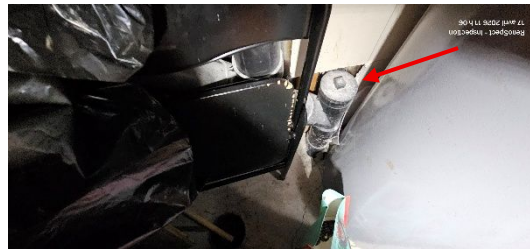
Drainage pipes (ABS)
No major anomalies
Cleaning inspection

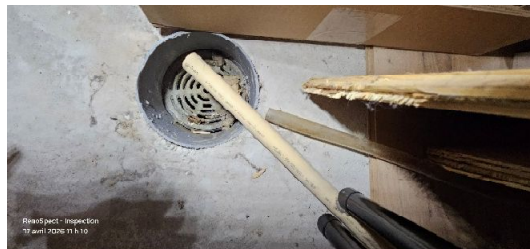
Floor drain
No major anomalies
(Mechanical chamber)

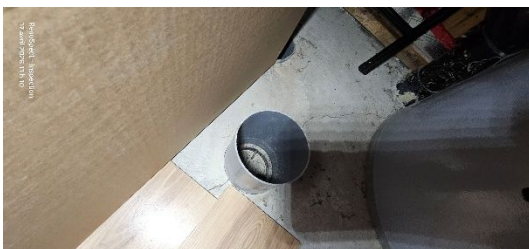
Check valve
No major anomalies
(Mechanical chamber)

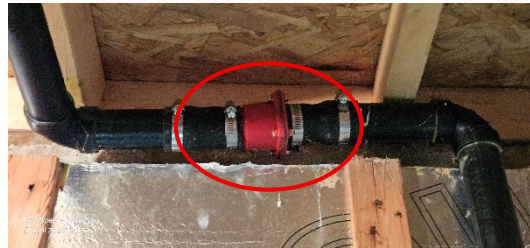
Check valve
No major anomalies
Cold room

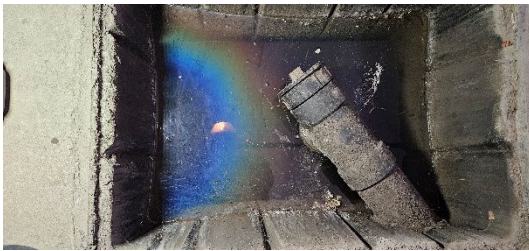
A careful examination of the garage's sump pit and gravity drain revealed no significant anomalies. Therefore, the inspector can confirm the absence of any apparent defects, indications of deficiency, or risks to the safety or physical integrity of this component at the time of the inspection.

Retention pit - Gravity drain
No major anomalies
Garage

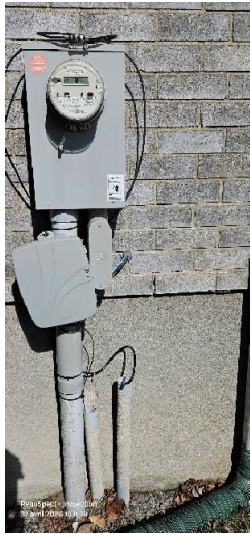
A careful examination of the above-ground portion of the underground main electrical service entrance revealed no significant anomalies. Therefore, the inspector can confirm the absence of any apparent defects, indications of deficiency, or risks to the safety or physical integrity of this component at the time of the inspection.

Main electrical entrance - Underground
Left side (front)

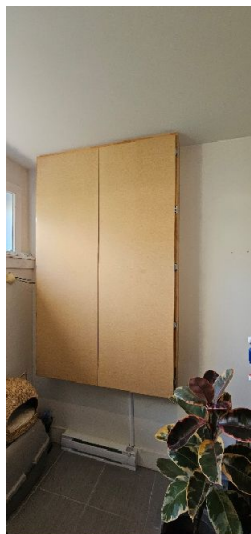
A careful examination of the 200A circuit breaker electrical distribution panel revealed no significant anomalies . Therefore, the inspector can confirm the absence of any apparent defects, indications of malfunction, or risks to the safety or physical integrity of this component at the time of inspection.

Distribution panel (1)
No major anomalies
Basement

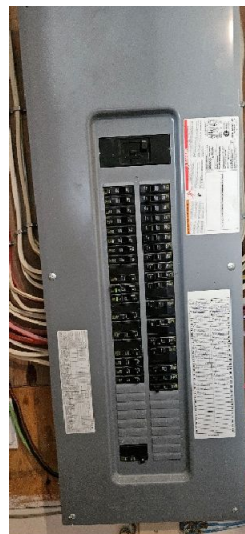
Distribution panel (2)
No major anomalies
Basement

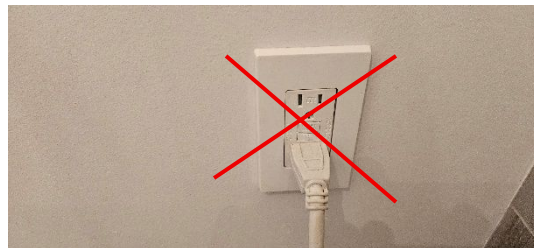
A careful examination of the light fixtures, outlets, and switches reveals a malfunction in a ground fault circuit interrupter (GFCI) outlet. Normal operation of this type of outlet should result in the circuit being disconnected when the test button is pressed and the circuit being reconnected when the reset button is pressed. The ground fault circuit interrupter (GFCI) is a highly sensitive protective device installed to guard against electric shock, especially in damp locations (outdoors, kitchen counters, bathrooms, etc.). This condition poses a high risk of electrocution and **requires immediate corrective action** to rectify the situation.

Plug into a GFCI outlet - **DANGER**
Bathroom

- Engage a general contractor, holding a valid RBQ license, to assess all the corrective work to be carried out;
- Hire a licensed electrician from the RBQ to repair the faulty outlet equipped with a GFCI in the bathroom;
- Call a plumber, holding a valid RBQ license, to assess the condition of the sump pump located in the cold room;
- Consider equipping the sump pump with a self-contained system in case of power failure.

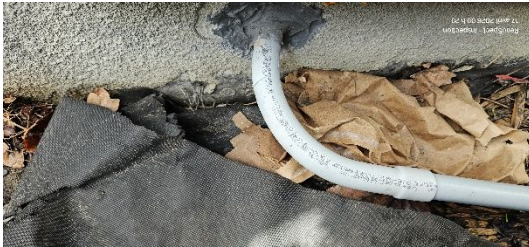
A careful examination of the charging station reveals no significant anomalies. Therefore, the inspector can confirm the absence of any apparent defects, indications of malfunction, or risks to the safety or physical integrity of this component at the time of inspection.

Charging station
Without any anomalies
Supply conduit

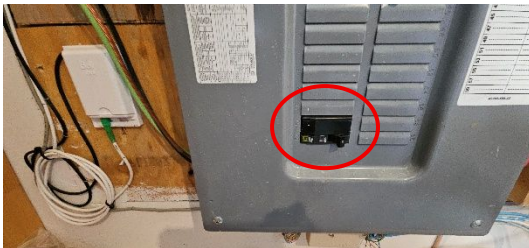
Charging station
Without any anomalies
60A / 240 Volt Circuit Breaker

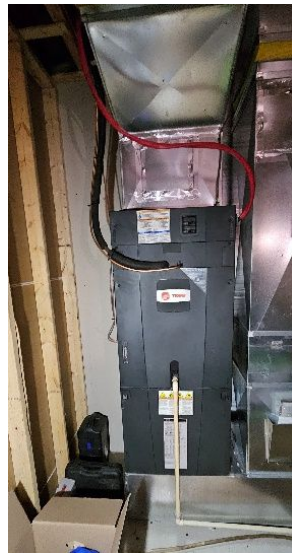
Central heating appliances
Basement

A careful examination of the forced-air central heating units revealed no significant anomalies. Therefore, the inspector can confirm the absence of any apparent defects, indications of malfunction, or risks to the safety or physical integrity of this component at the time of inspection.

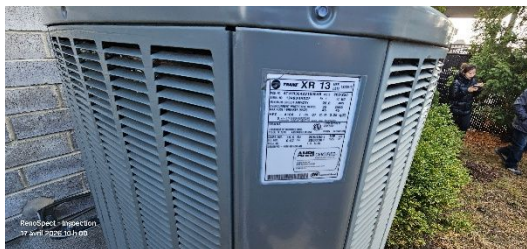
Air conditioning units / heat pumps (2)
No major anomalies
Rear facade

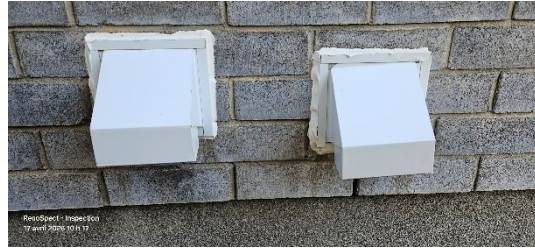
VRC – External Registers
No major anomalies
Right side

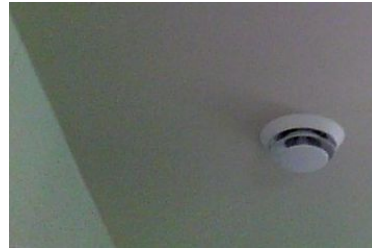
HRV – Ceiling Fan
No major anomalies
Bathroom

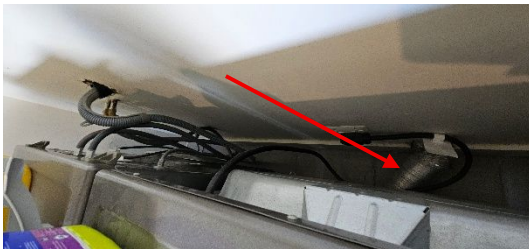
A careful examination of the aluminum dryer vent revealed no significant anomalies. Therefore, the inspector can confirm the absence of any apparent defects, indications of deficiency, or risks to the safety or physical integrity of this component at the time of inspection.

Dryer vent - Aluminum
No major anomalies
Basement

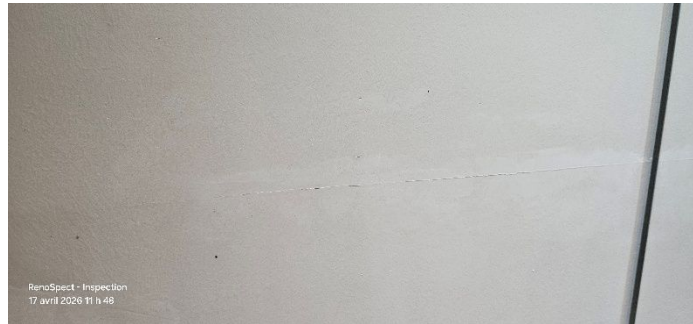
Wall finishing coating
Repair observed
Bathroom

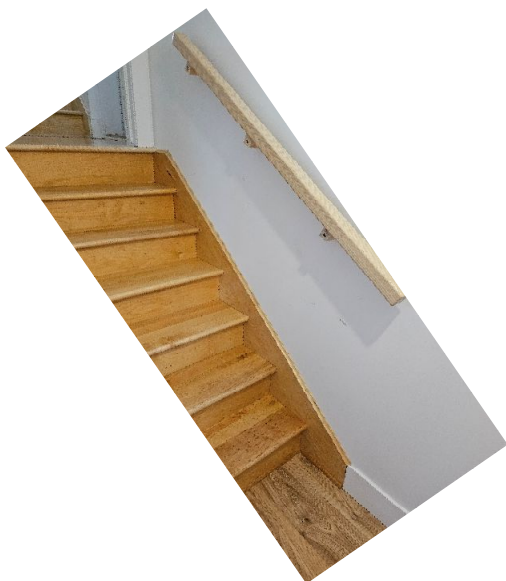
Interior staircases
No major anomalies
Towards the 1st floor

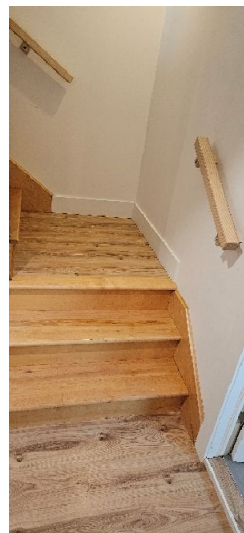
Interior staircases
No major anomalies
Basement

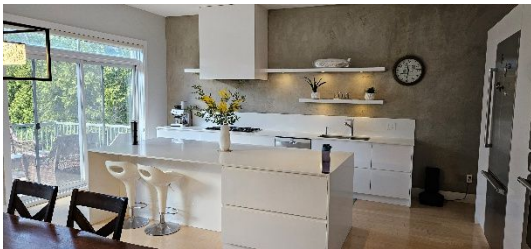
A careful examination of the kitchen and bathroom cabinets and countertops revealed no significant anomalies. Therefore, the inspector can confirm the absence of any apparent defects, signs of deficiency, or risks to the safety or physical integrity of this component at the time of the inspection.

Cabinets and countertops (1)
No major anomalies
Kitchen

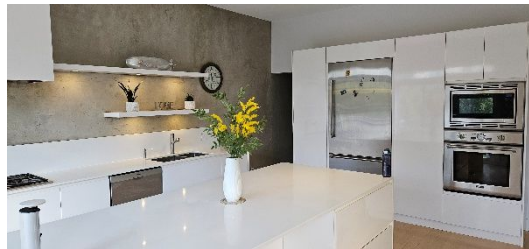
Cabinets and countertops (2)
No major anomalies
Kitchen

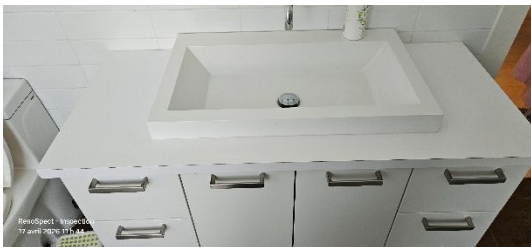
Cabinets and countertops (1)
No major anomalies
Bathroom

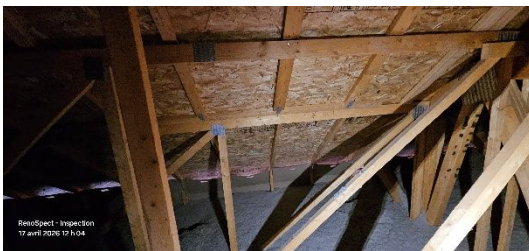
A careful examination of the cellulose insulation in the attic revealed no significant anomalies. A poorly insulated roof can cause up to 30% heat loss. Adding insulation that meets current energy efficiency standards is easy to do using cellulose. Therefore, the inspector can confirm the absence of any apparent defects, signs of deficiency, or risks to the safety or physical integrity of this component at the time of the inspection.

Attic - Thermal insulation and ventilation
No major anomalies

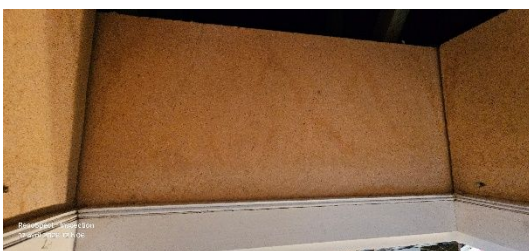
Attic - Access hatch
Walk-in closet, 2nd floor
