INSPECTION REPORT

PRE-PURCHASE

SUBJECT: PRE-PURCHASE INSPECTION OF CORNEILLE STREET, BROSSARD (QC)
J4Z 0K2.

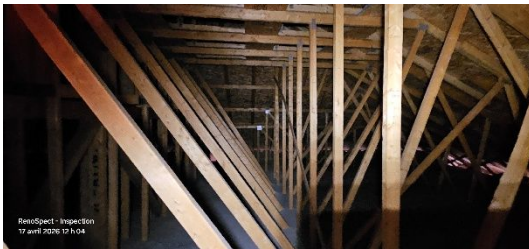
A careful examination of the prefabricated timber trusses and particleboard decking revealed no significant anomalies. Therefore, the inspector can confirm the absence of any apparent defects, indications of deficiency, or risks to the safety or physical integrity of this component at the time of inspection.

Farms
No major anomalies
Attic

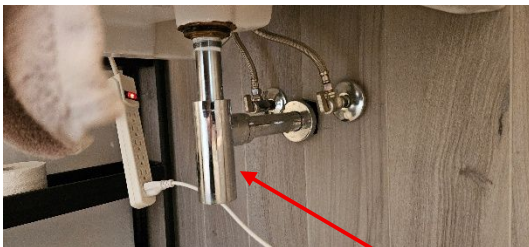
Drainage pipes

Things to watch out for (Frequent blockages)

Sink

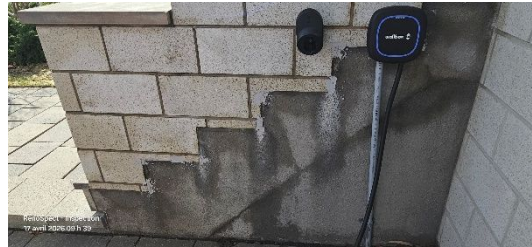
Smart charging station
Without any anomalies
Pulsar Plus 48A Wallbox
